**Water Quality Concerns
and
Treatment Parameters for Armanda Lake**

M. Kalin, Boojum Research Limited

March 1, 2001

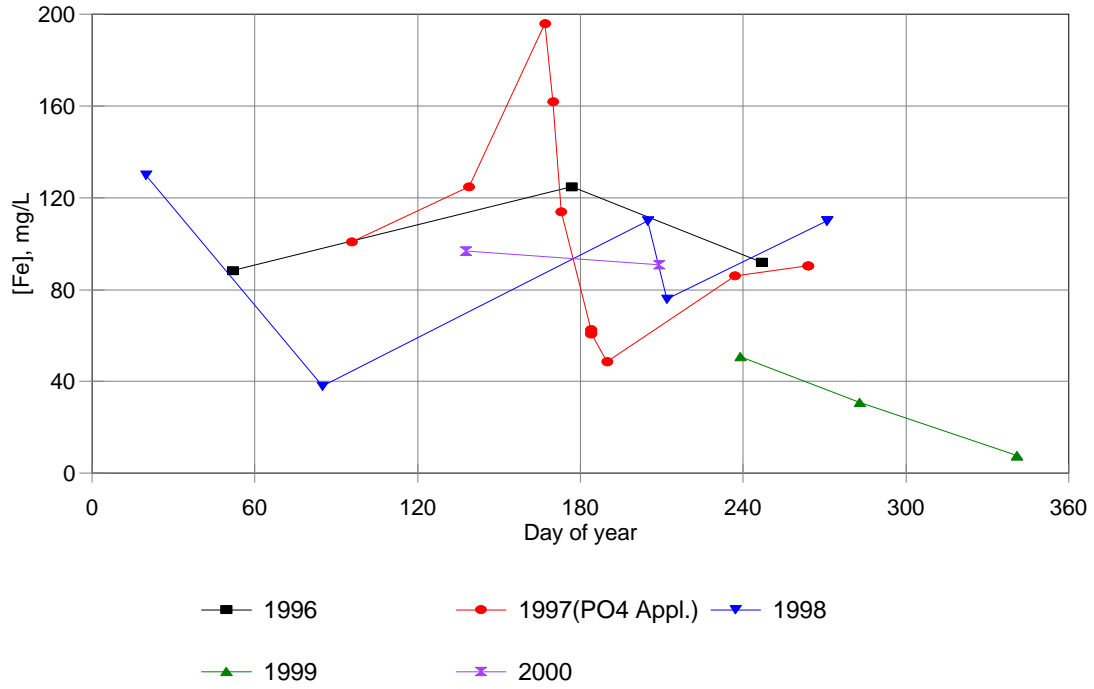
Fig.1: Middle Mud Lake, MML
Seasonal Iron Concentration

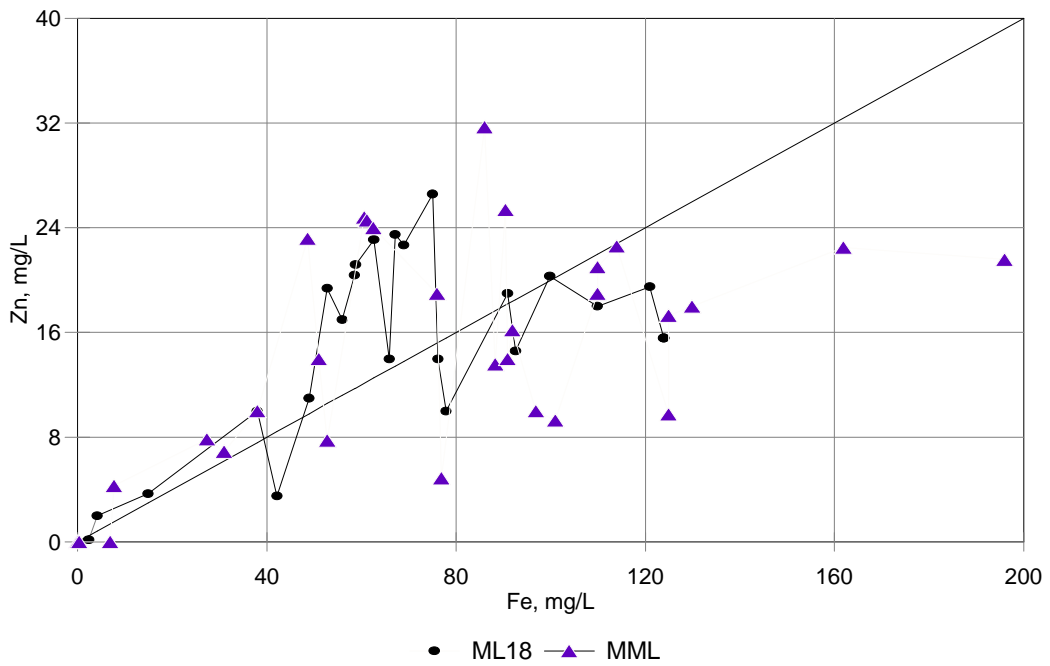
Fig.2: ML18 and MML
Zinc versus Iron

Zinc and iron concentrations in the water column are somewhat linked. The concentration of zinc is 5 times lower than iron in Mud Lake Outflow and Mud Lake Middle (**Figure 2**). If iron is precipitated from the water, then through adsorption and co-precipitation processes also some zinc is removed from the water column, both from the natural iron-hydroxide precipitation and the enhanced precipitation with phosphate. Phosphate rock also contains carbonate, which adds to the neutralizing capacity of the sediments.

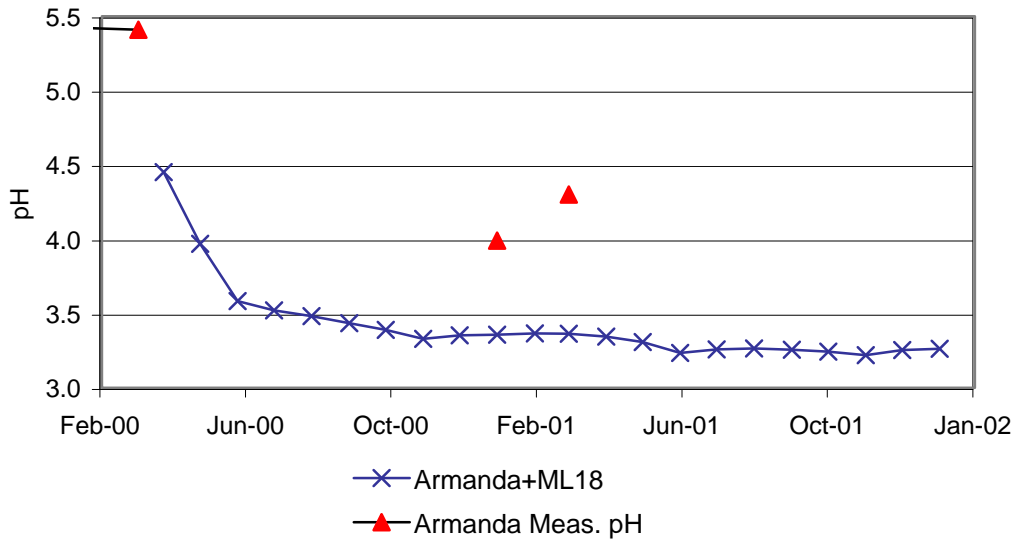
Fig. 7: Armanda L- Beaver Dam Intact
Initial pH 5.41: ML18 Input pH 2.7

In [Figure 7](#) the conditions with the beaver dam intact are modeled in the way described above. For the last years conditions taking the original pH of Armanda lake as 5.4 with the discharge from Mud lake, we would have expected a pH of 3.5 in Armanda lake. Measured Armanda Lake pHs for December, 2000 and early February, 2001 are shown. The measured values of pH are higher than would be expected from the model when input pH of 2.7 is used.

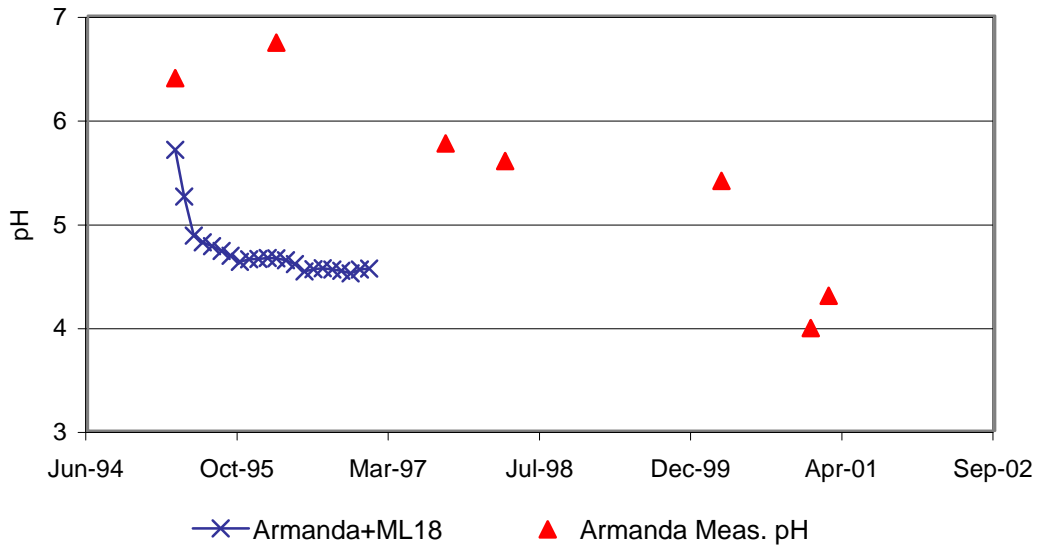
Fig. 9: Armanda L. - Slower Acidification
Initial pH 6.4 : ML18 pH 4.0

To demonstrate buffering capacity of the lake and its sediments, in [Figure 9](#) we model the long term situation 1) slow acidification and 2) in [Figure 10](#) rapid acidification simulating the beaver-dam break, using the same approach as outlined in Table 4. Again for the model, both scenarios (slow and rapid acidification) we used measured average value of pH as input from Mud Lake to Armanda Lake for 1995 and 1996. The initial pH depression differs in the two scenarios. Looking at the long term simulation starting in 1995, even using Mud Lake outflow water with a pH of 2.7(which was not the case throughout this period) the pH should have rapidly decreased. In the slow acidification it would have reached the present pH of 4.5 by 1995 ([Figure 9](#)) and in the rapid acidification the pH would have reached 3.2 by 1995. However, in reality, pH decreases to less than H 5.0 did not occur until the year 2000, six years after acidification of Mud Lake was first measured and the discharge to Armanda Lake started.

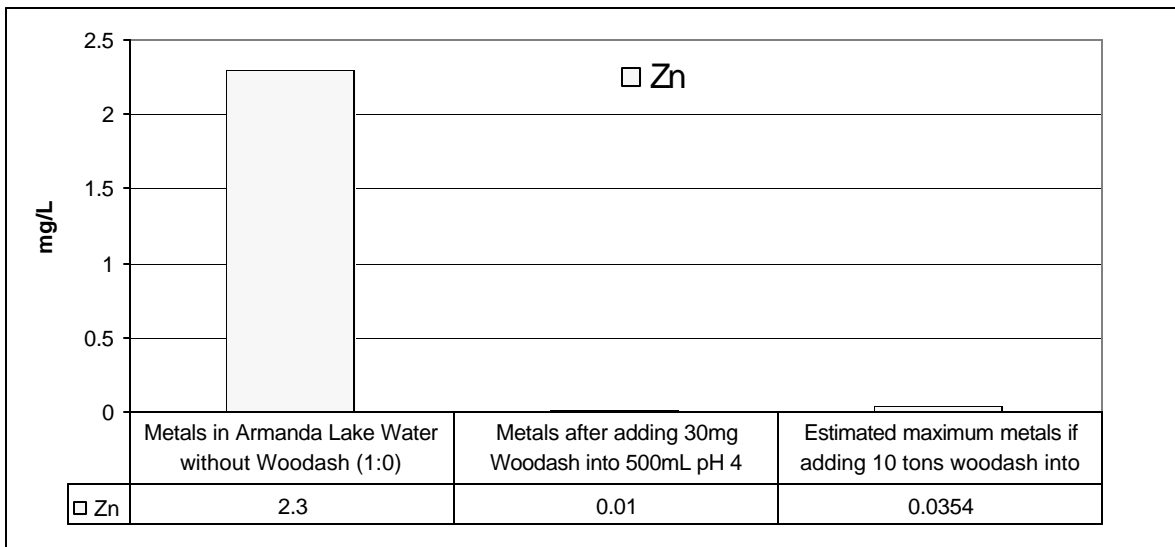
Figure 11: Metals in Armanda Lake before and After Wood Ash Addition

In Figure 11, the concentrations of metals in Armanda Lake are plotted for Al, Pb, Mo Cd, Cr, Co, Cu, Ni and for Zn, and those concentrations are reported from the supernatants of the experiment (Table 5). This assessment of the additions of wood-ash along with the maximum expected concentrations shows, that the addition does not alter Armanda Lake measurably, when compared to existing conditions.

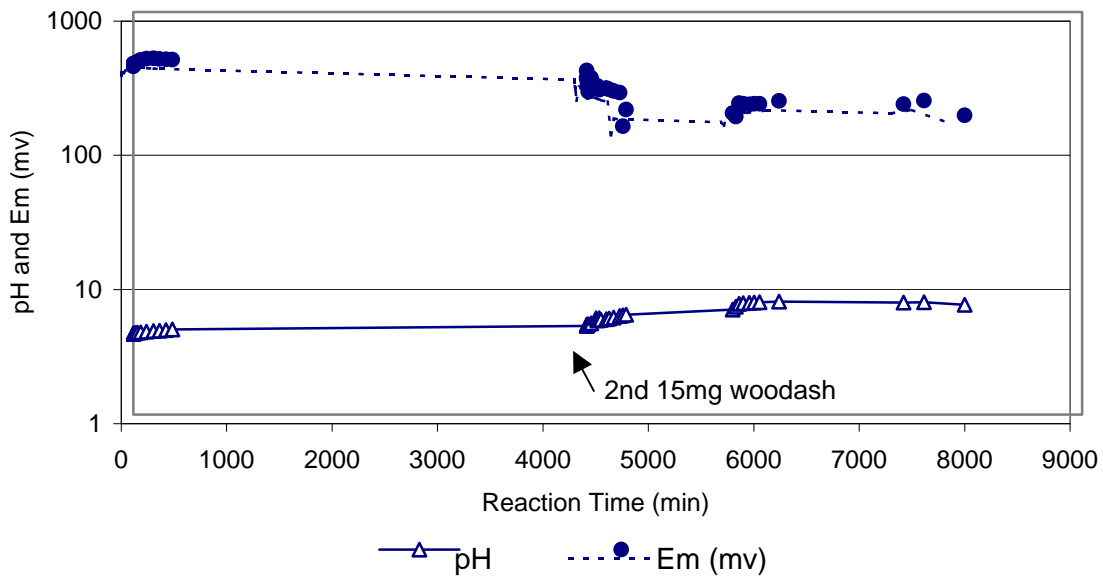
Fig. 14: Practical Dosage of Wood-ash for Armanda Lake

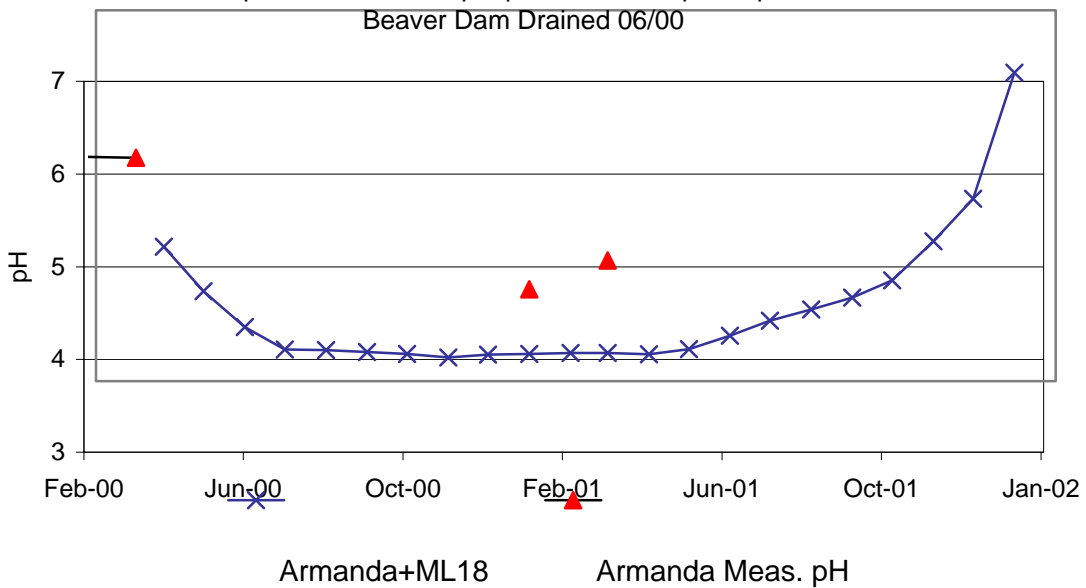
Fig. 15: Armanda L. - Treated ML18
Initial pH 5.41 : ML18 Input pH 2.7, then Apr 01, pH 10.78:
Beaver Dam Drained 06/00

We simulated therefore a treatment scenario for Armanda Lake, where we add pH 10.7 water to the creek leaving Mud Lake (Figure 15). As a starting pH a value of 5.4 was used (assuming a conservative increase in pH due to the winter application of wood-ash to Armanda Lake) . Using this model result, it appears that we have to treat for at least one entire year. If the winter additions is not sufficient to increase the pH to 6.0 we have defined the parameters for post spring run-off treatment.
